CeraNews

Improve Arthroplasty

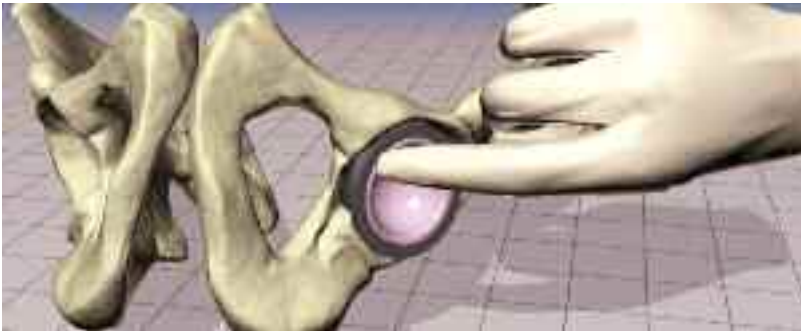
The correct position of the ceramic insert within the acetabular cup can be checked by running a finger along its rim.

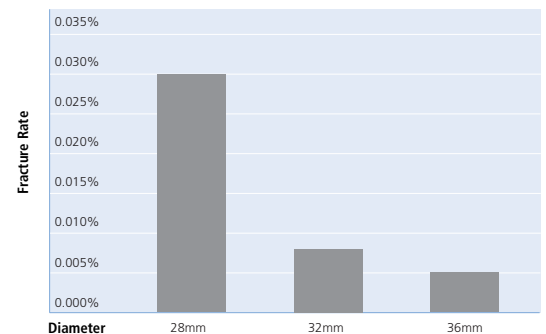
BIOLOX®*forte* femoral ball heads

CeramTec distributed approximately 2,300,000 ball heads in the period from January 2000 to March 2008 (around 2,050,000 BIOLOX®*forte* and 250,000 BIOLOX®*delta*). The in-vivo fracture rate for ball heads made of the material BIOLOX®*forte* is 0.021%, or roughly 20 per 100,000 implants. The in-vivo fracture rate for ball heads made of BIOLOX®*delta* is 0.003%, or 3 per 100,000 implants.

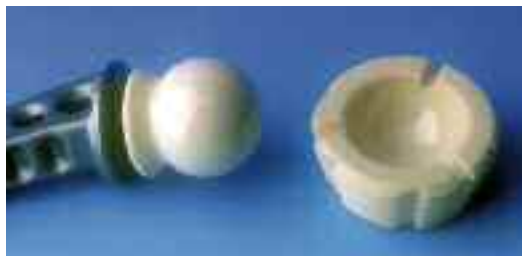
Ceramic-on-ceramic articulation components from the 1970s

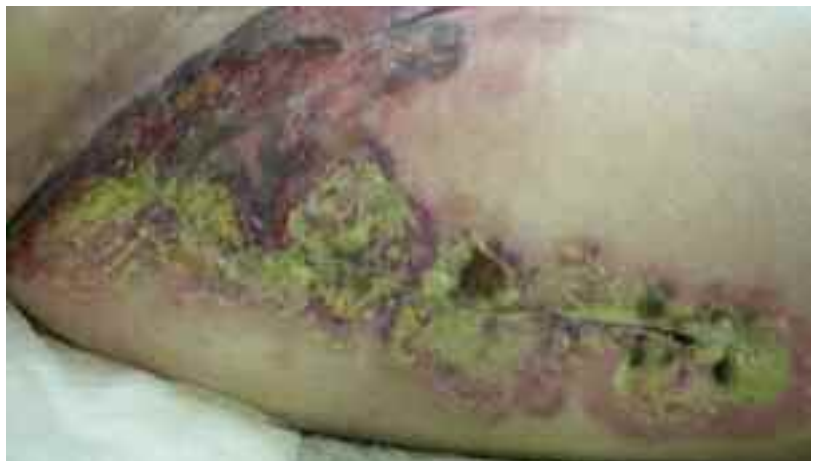
According to investigations conducted by the Patient Safety Committee of the AAOS, 368,600 patients are admitted to hospital with multi-resistant Staphylococcus aureus (MRSA) infections each year in the United States alone. The infections prove fatal for 18,650 patients. Such infections raise the standard treatment costs by 30% to 100%. Our photo shows a deep infection after THA.
(Source: CeramTec AG)

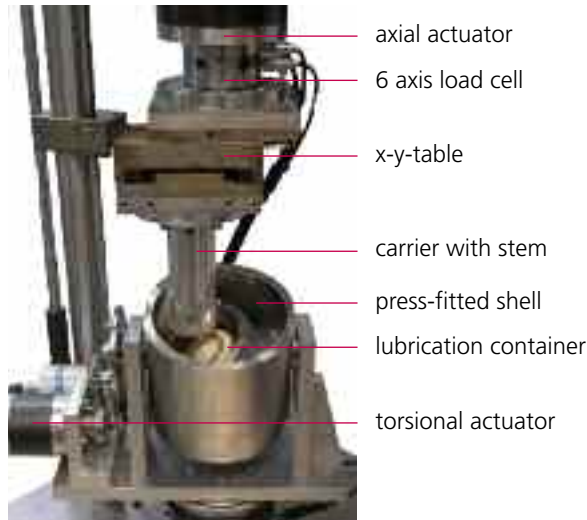
Hip simulator for acoustic measurements:
Movement and load cycles are examined for the production of vibrations and noises using laser vibrometry and the sensory analysis of airborne sound.

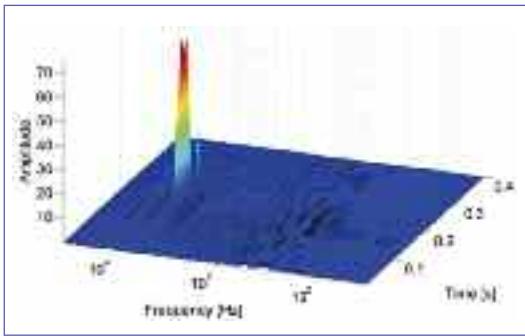
Time-frequency representation of a squeaking sound:
A squeaking sound arises and ceases (amplitude axis) in the course of the movement cycle (time axis).

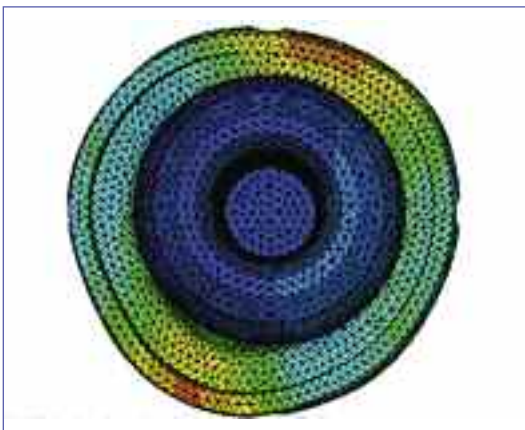
Sample calculation result:
Maximum deformation of a cup during squeaking. The cup moves in a certain relation to the ball head which gives rise to a coherent vibration perceived as a squeaking sound.

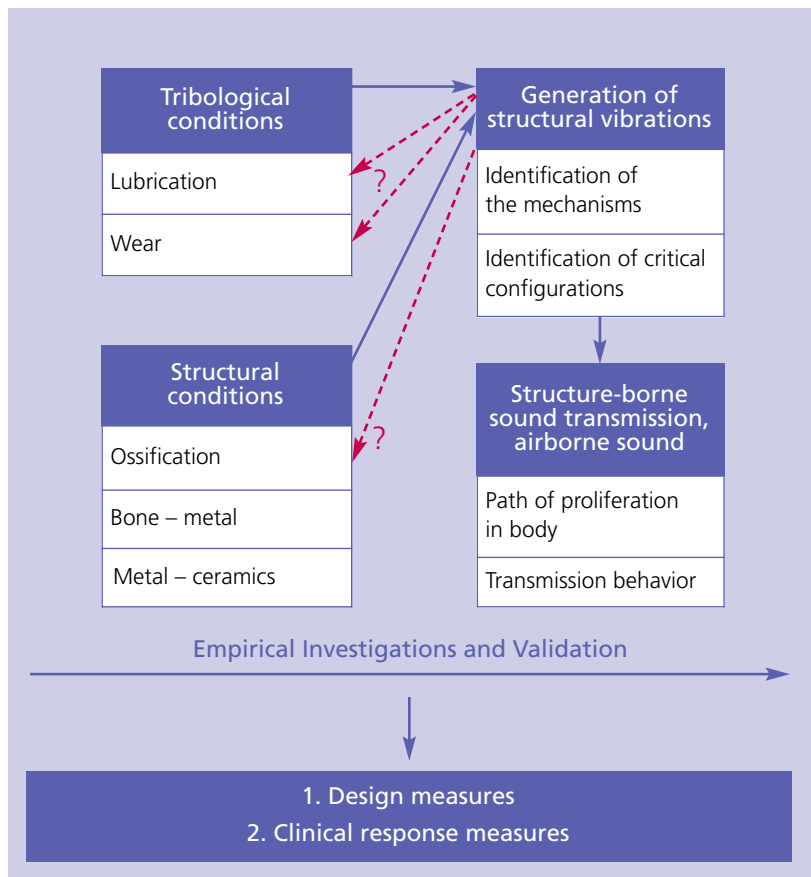
Chains of action and investigational method:
In addition to structural dynamics and acoustics, tribological factors and ossification also influence noise development.

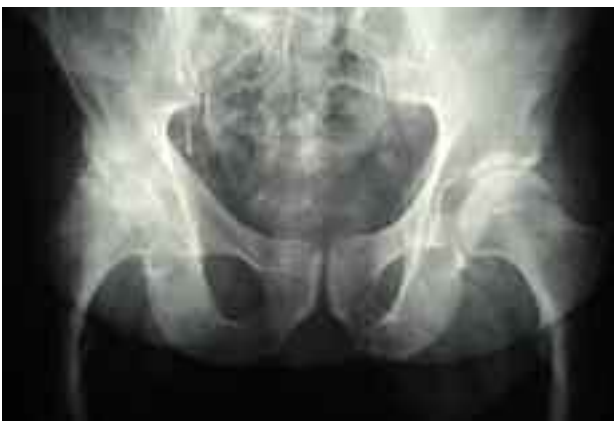
Left (preop): 60-year-old patient showing coxarthrosis with femoral head necrosis and caudal osteophytes on the rim of the cup (pincer impingement); right (postop): treatment with ceramic-on-ceramic bearing (BIOLOX® delta) after osteophyte removal (ball head size: 36 mm) Source: H. Röhrig, M.D., Bonn University Orthopaedic Clinic

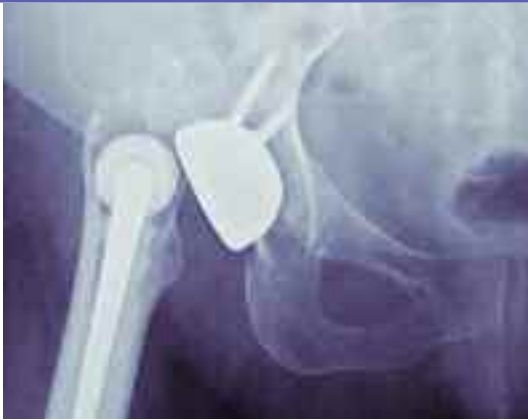
Impingement and dislocation are a frequent complication in younger and more active patients. Source: W. Mittelmeier, Orthopaedic Clinic, Rostock University, Germany

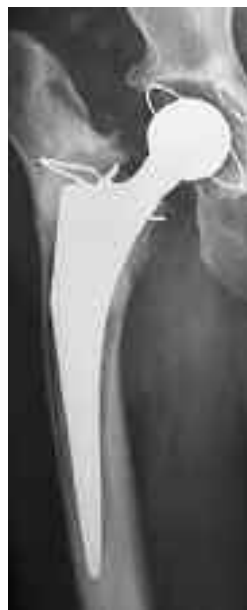
Reason for revision: loosening on both sides in a 44-year-old female patient

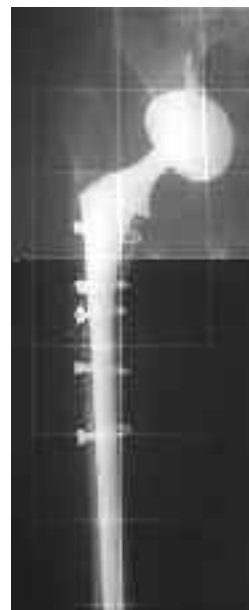
Uncemented revision with femoral osteotomy and ceramic-on-ceramic bearing
